Inspection Report

Minerals Regulatory Program

Mine Name: La Sal/Snowball
Operator Name: Denison Mines

Permit number: M0370026
Inspection Date: April 30, 2008
Time: 2:45-3:15 PM

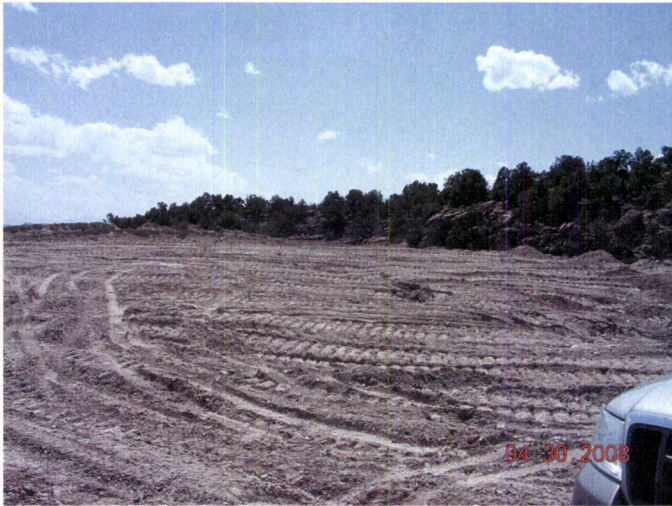
There had been some grading on top of the waste pile at the Snowball Mine, and some areas had settled. I could see no slumping on the sides of the pile.

Photo 1. This is the top of the waste pile at the Snowball Mine.

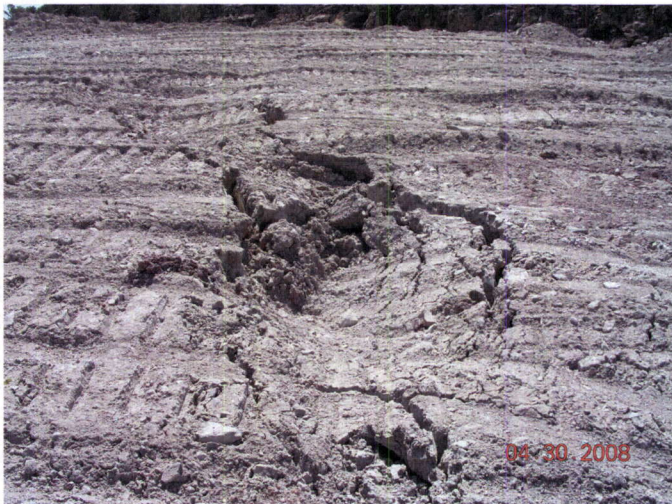
The operator's representative informed me that the reason for the settling was that some items had been buried in the waste pile. I wasn't worried when I was speaking with the representative, but I have become more concerned because I believe this would require approval from the Division of Solid and Hazardous Waste and because it could potentially de-stabilize the pile. I need to follow through on this issue, and there is a chance that any buried items might need to be removed.

Photo 2. There has been some slumping on top of the waste pile.

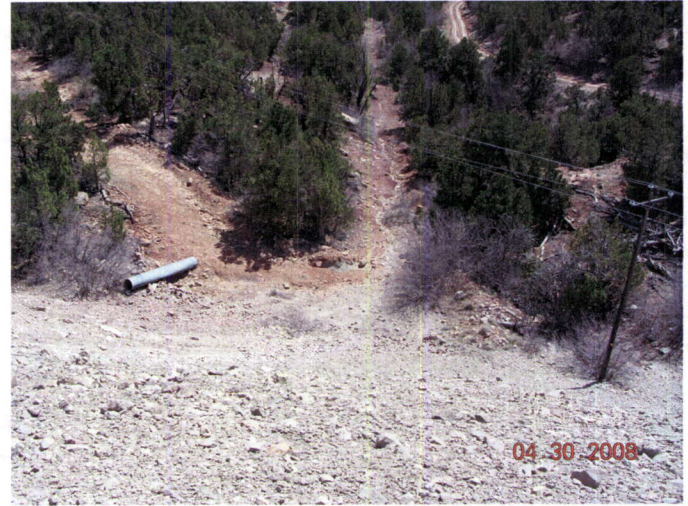
There is no sediment control at the base of the waste pile at Snowball.

Photo 3. Some form of sediment control should be installed at the base of the waste pile, at least where it would directly impact the drainage.

I recommend, and have previously recommended, that sediment control be installed at the base of the waste pile at Snowball.
